SML 100085

NE 12-063-19-W4

Aggregate Supply Analysis

Prepared for: JMB Crushing Systems ULC

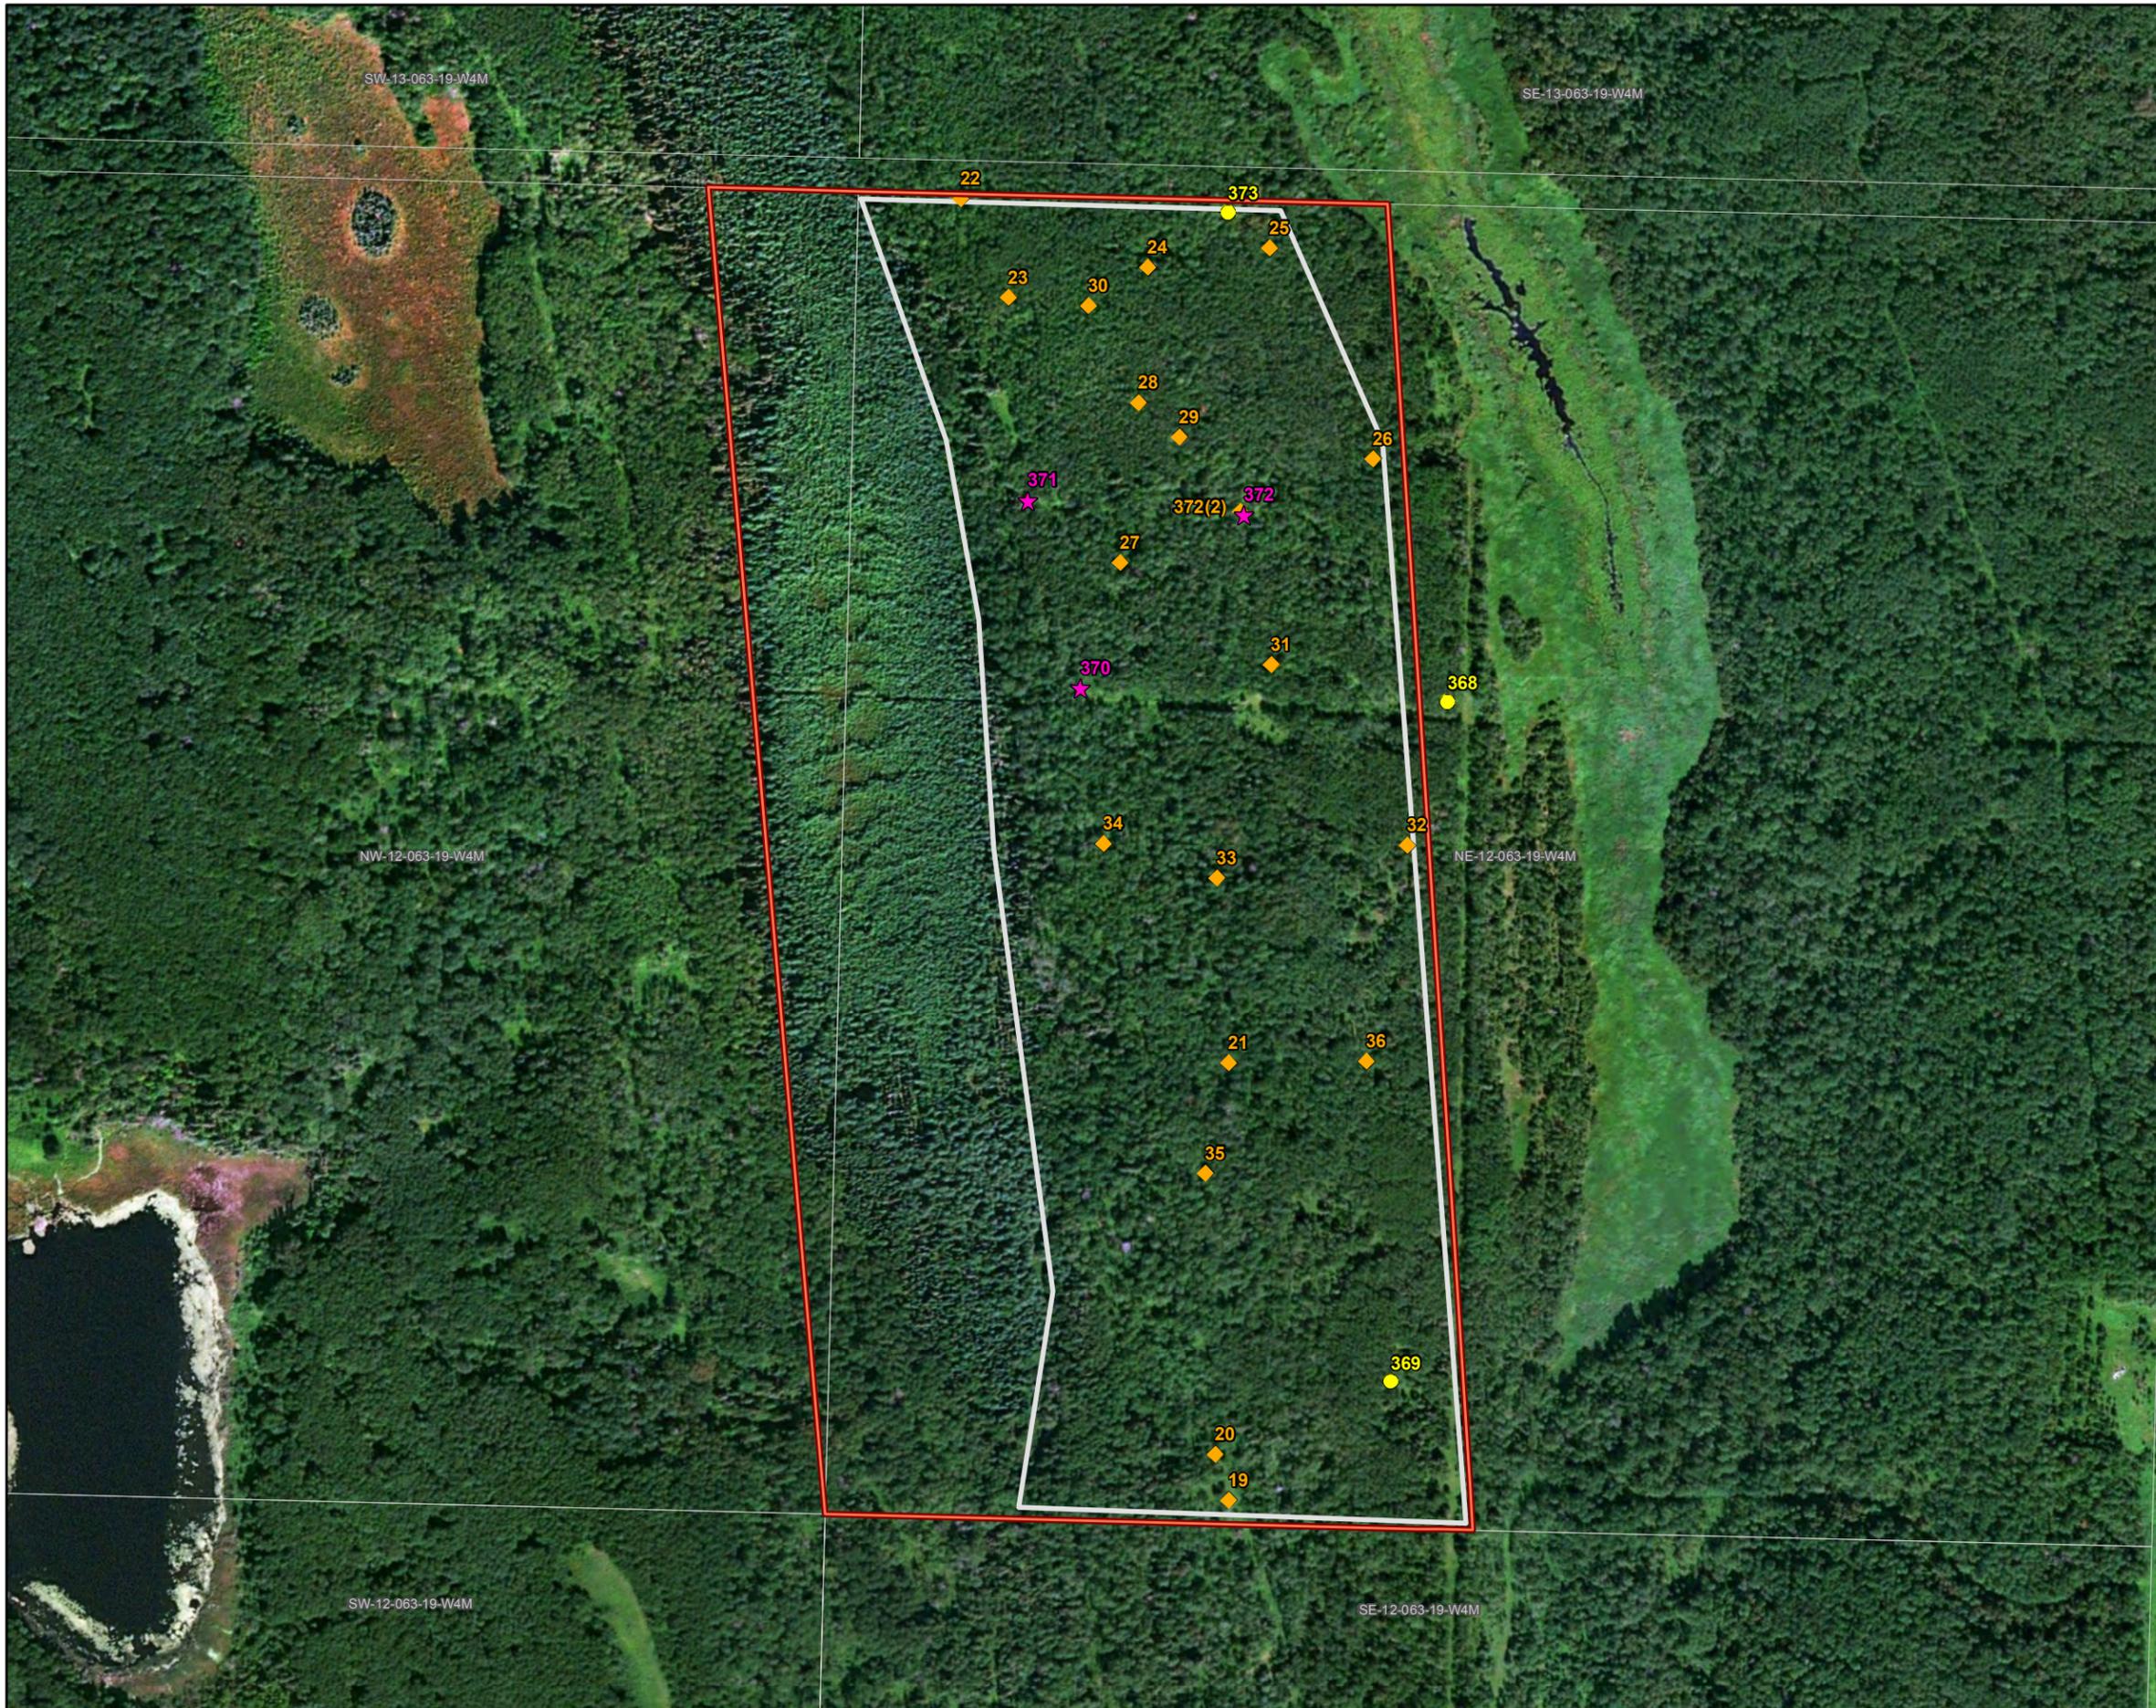
Appendix 1 – Test Hole Locations

SML 100085

Aggregate Supply Analysis

- ★ Previously Drilled
- Sample Test Holes
- Previous Test Holes
- Used in Comparison Analysis
- ◆ Random Test Holes
- ▭ SML100085
- ▭ Estimated Mining Area (20.26 ha)

Data analysis was completed using Microsoft excel, with previous and new testing data being entered into similar formatted spreadsheets. All raw data was entered in feet and converted to metres for analysis. Previous testing GPS data was used to map sampled test hole locations. New random testing locations from Spec Aggregate were mapped using UTM coordinates. Refer to Appendix 1 for testing locations.

After communications with Spec, it was determined that the aggregate deposit was located within an isolated esker and not present across the entire SML area. This determination was due to on-site observations and test holes with little aggregate and/or predominately clay layers in close proximity to, but not within SML boundary. To establish the movable area for the new volume calculation, GIS mapping was used to select a portion of the SML based on appearance (photo imagery) and the location of test holes with little aggregate and predominate clay layers. The movable area was determined to be 20.26 ha.
